A STUDY OF CORROSION IN BALANCED FLUES DEPENDING ON OPERATION CONDITIONS

Bjarne Spiegelhauer, Danish Gas Technology Centre
Per Persson, Hovedstadsregionens Naturgas (Greater Copenhagen Natural Gas)
Marius Kildsig, Danish Gas Technology Centre

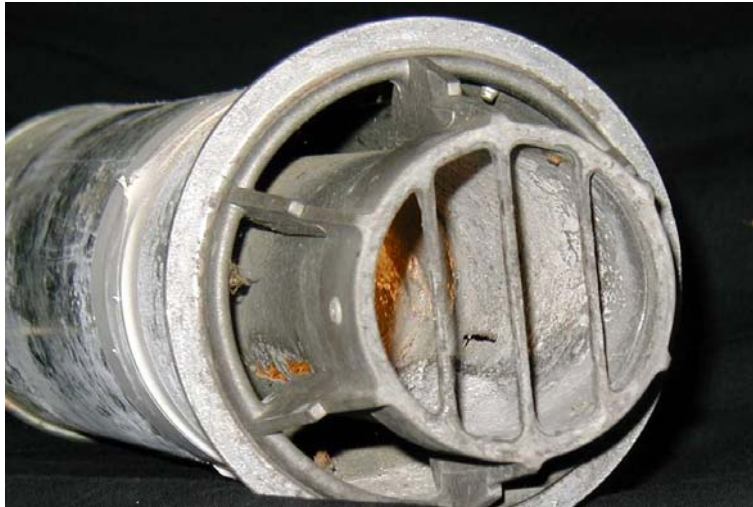
Figure 1: Example of corrosion in horizontal balanced flue

It turned out that approx. 11% of the flues showed serious signs of corrosion, and approx. 22% had begun to choke up. It was remarkable that systems with a horizontal balanced flue had problems more often than systems with a vertical balanced flue.

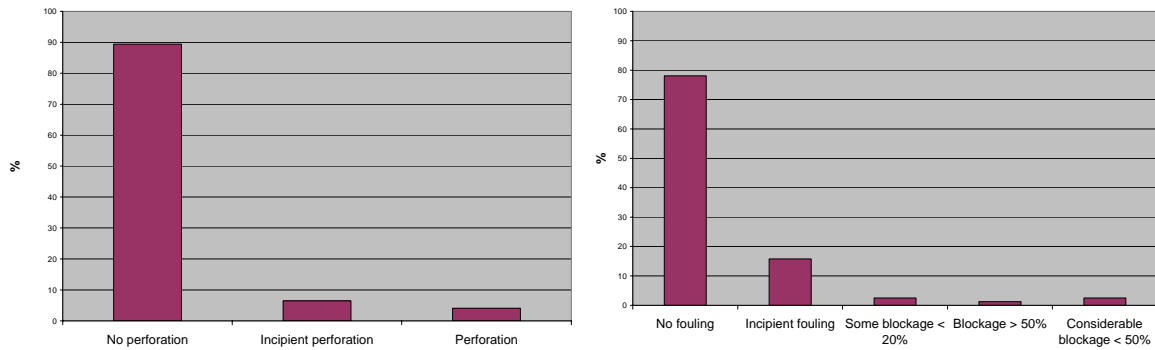
Figure 2: Corrosion and blockage

When aluminium flues are corroding the aluminium oxide swells and causes fouling and blockage, whereas stainless steel flues are corroding by way of "pin holes" in the pipe rather than an even corrosion.

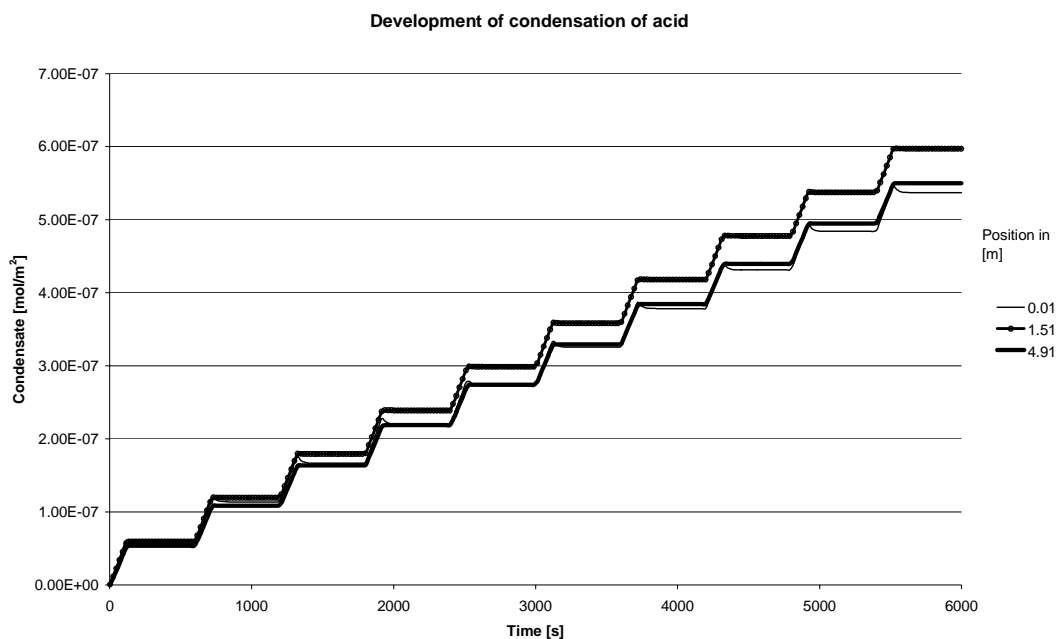
Figure 5 and Figure 6 show the results of the calculations of the standard case. Figure 5 shows the total amount of acid (SO₃) condensing on the aluminium surface during a period of 1 hour 40 min. Figure 6 shows the variation of the strength of acid in the film through the same period 0.01 m from the flue gas inlet. From Figure 5 it appears that the amount of acid condensate increases every time the boiler starts and that there is hardly any evaporation when the boiler has stopped. From Figure 6 it appears that the strength of the sulphuric acid varies during the boiler start/stop cycle. This varying strength of acid is caused by a temperature controlled condensation and evaporation of water from the acid film, respectively. The film is thickest at the lowest strength of acid - which means that the acid is more mobile. Figure 6 shows that the strength of acid is 50% when the boiler starts. At 50% strength of acid the sulphuric acid is slightly corrosive. As the temperature rises, the water evaporates and the strength of acid increases at the same time as the acid mobility decreases. At 80% strength of acid the acid is expected to be considerably corrosive but only slightly mobile. When the boiler stops, the strength of acid will change almost instantly from 80% to 90% without a corresponding drop in temperature. At this change it is expected that the corrosiveness of the sulphuric acid will decrease. When the boiler stops, the flue temperature and thus the acid film temperature will fall. Because sulphuric acid is hygroscopic it will draw water from the atmosphere at falling temperatures. When the boiler stops the strength of acid will decrease, which is also shown in Figure 6.

Figure 5: Total molar mass of SO₃ that has condensed on the aluminium surface of a standard flue during a period of 1 hour 40 min.

In the standard case an acid film condenses evenly in the length of the flue, and the amount of acid increases gradually according to the operation time of the boiler, as shown in Figure 5. This means that the sulphuric acid has sufficient time to dissolve/corrode the aluminium flue. In practice, the amount of condensed sulphuric acid means that the film of sulphuric acid developed can only cause problems if either the acid or the corrosion products are accumulated in selected spots of the flue. The fact that the strength of acid varies with the start/stop cycle increases the risk that the acid accumulates in selected spots of the flue. Furthermore, the corrosion products are likely to accumulate in exposed spots of certain flues, since they tend to sift down and accumulate in the bends of the flue. It is estimated that both the effects mentioned above will influence the blockage/corrosion problems. The geometrical design of the flue, and other factors, will affect the velocity of a blockage/perforation process of the flue. In practice, the random inspection showed that blockage or perforation may occur after 3 to 10 years. Calculations showed that this will only occur if the acid/corrosion products do accumulate in selective spots of the flue.

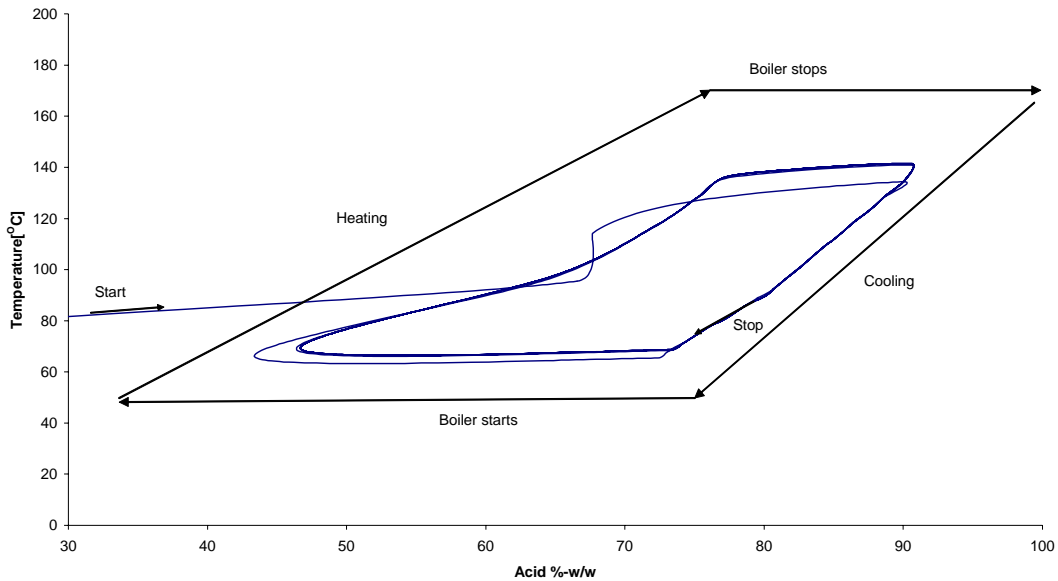
Strength of acid as a function of temperature close to the inlet, position 0.01 m

Figure 6: Mass ratio between water and acid in the acid film of a standard flue during a period of 1 hour 40 min.
